### PATIENT HISTORY

### TREATMENT APPROACH

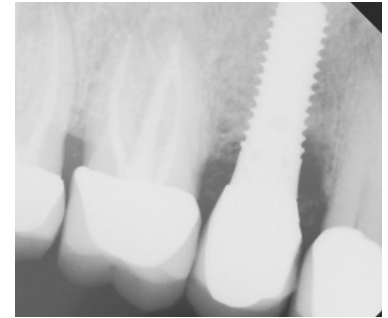
**Fig. 1: Pre-op radiograph**

The patient was diagnosed with site-specific peri-implantitis around #4 and localized beginning-to-moderate periodontitis interproximal to #26-27 with probing depths of 5 to 7mm. Probing depths around #4 were buccally (distal to mesial) 7,7,9mm and lingually (mesial to distal) 9,7,7mm with heavy bleeding upon probing circumferentially with zero mm of visible facial recession recorded. The implant was not mobile, but there was bone loss on the mesial aspect to the third thread as noted on radiographic exam. (fig 1)

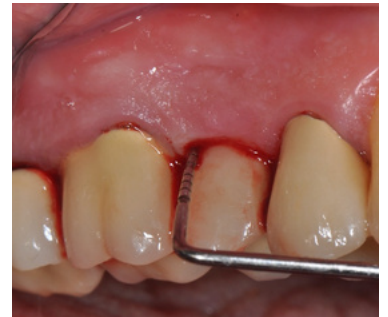
**Fig. 2: Pre-op clinical photo showing heavy BOP**

A 63-year-old male patient was referred in January 2015 after a routine cleaning at his restorative dentist's office where the hygienist recorded pocketing and heavy bleeding upon probing around an implant in site #4. (figs 1-2) The Straumann RN TE implant was placed in 5/12/2003 under my care due to a previous root fracture of a root canal treated tooth that had been extracted by a local surgeon 6 months prior to presentation. The final crown was cemented with a polycarboxylate cement in 2003. The patient had been very compliant with regular every 6 months prophylaxis with his restorative dentist. The patient had a medical history of A-Fib and high cholesterol. Medications to control them included a statin, metoprolol, and warfarin. Parafunctional habits may have been contributory to the failed tooth. A nightguard appliance had not been recommended previously.

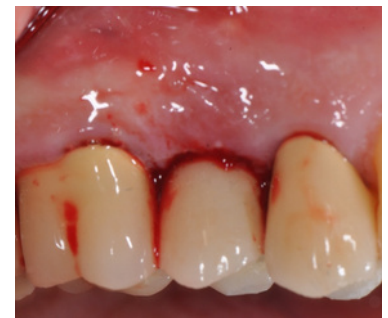
**Fig. 3: GE immediately post LAPIP treatment**

LAPIP procedure was performed for #4 and LAR (laser assisted regeneration) completed for #2,3,5 (total of 542 joules used in the upper right sextant) and LAR #26,27 (total of 604 joules used) in February 2015 (fig 3). The patient experienced zero out of ten on a discomfort scale (1 to 10 in degree of discomfort) at his follow-up visit in 2 weeks immediately post-surgery.

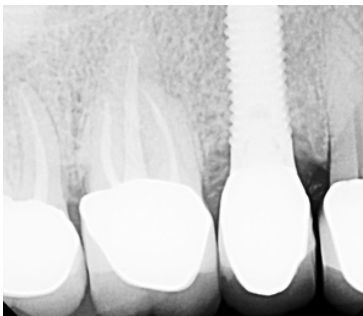
Fig. 4: 1 year post-op

One year post-op radiographs taken in July 2016 (fig 4) showed clear bone fill with decreased probing depths. No bleeding or suppuration were noted during post-op exams and the patient maintained good plaque control. The patient returned to the care with his restorative dentist for periodontal maintenance visits every 4-6 months.

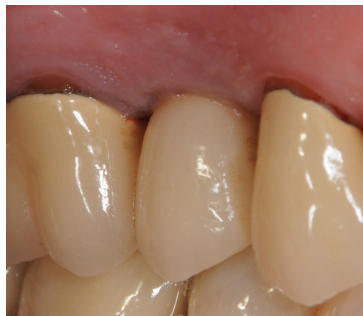
Fig. 5: 7 year post-op

A 7-year post-treatment exam (fig 5) and digital radiograph (fig 6) was completed in May 2022, indicating continued health of the implant and increased bone density and complete fill on the mesial and distal aspects. Probing depths were buccally: 4,2,4mm (distal to mesial) and 4,2,4 mm (mesially to distally) with light bleeding noted on the mesial aspect upon probing. No recession facially was noted associated with #4, however the natural tooth #5 recorded an additional 1 mm of buccal recession. The tissues appeared healthy for the upper right and lower anteriors at 7 years. He again expressed his pleasure and gratitude of our ability to treat and maintain his #4 implant non-surgically with the state-of-the-art advanced laser technology with the PerioLase® MVP-7™ Nd:YAG laser.

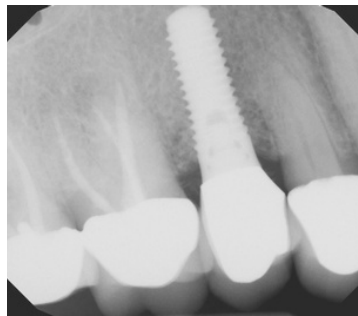
Fig. 6: 7 year post-op
